CASUALTY REPORT

**DIVISION FOR INVESTIGATION
OF MARITIME ACCIDENTS**

Collision between Chinese bulk carrier FU SHAN HAI and Cypriot container vessel GDYNIA

FU SHAN HAI sank after the collision

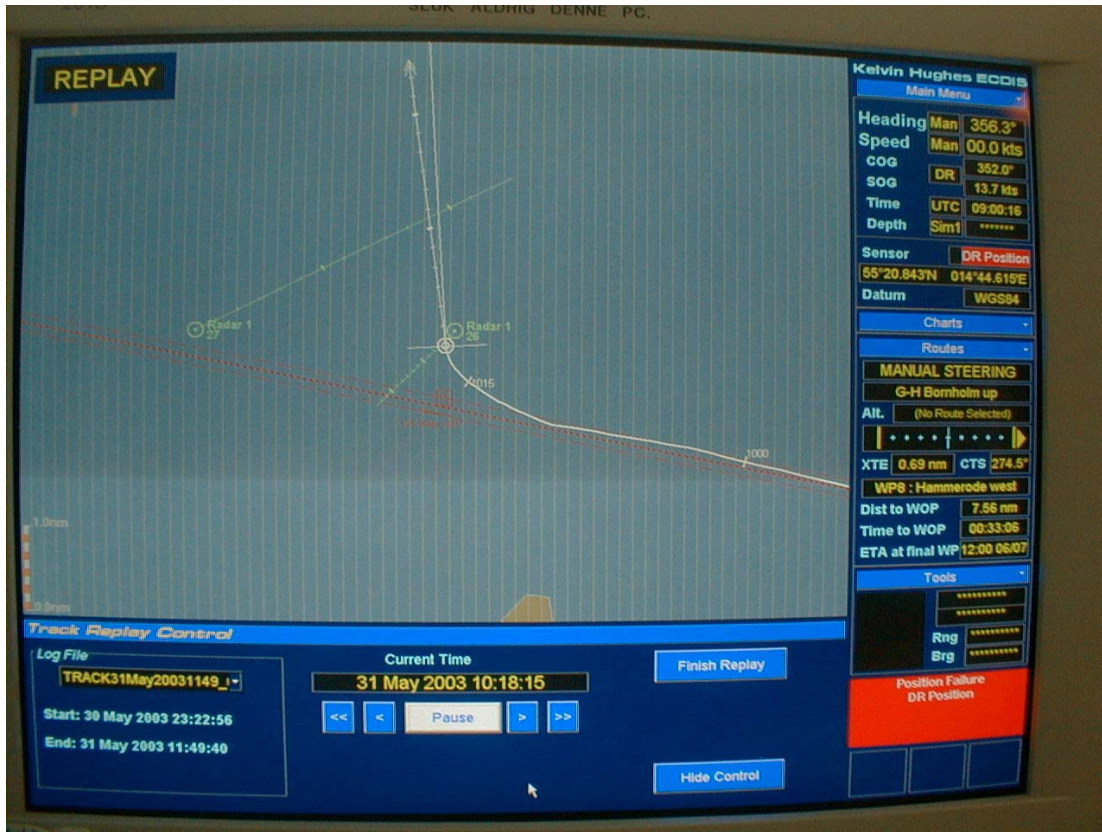
On 27 June 2003 the manufacturer Kelvin Hughes had been able to retrieve the information from the electronic chart data system on behalf of GDYNIA's owner. Not only the track was retrieved, but also the electronic plot (radar overlay) of FU SHAN HAI.
